# Performance Evaluation of Pontianak Kapuas Indah Market from Architecture and Behaviour Aspect

M. Ridha Alhamdani<sup>1</sup>, Dian Perwita Sari<sup>2</sup>

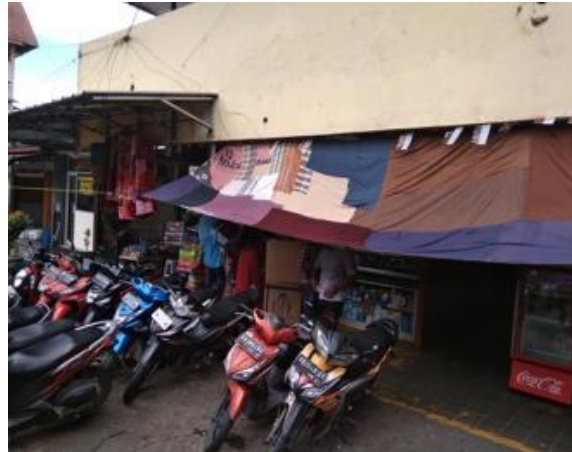
Building entrance access is strategical, can see clearly, and direct access from the parking and main road. There are three entrances access, first in front of the building, in the next of building, and behind the building for visitor access from the Kapuas River dock.

**Figure 4.** Building access from the side entrance  
(Source: author).

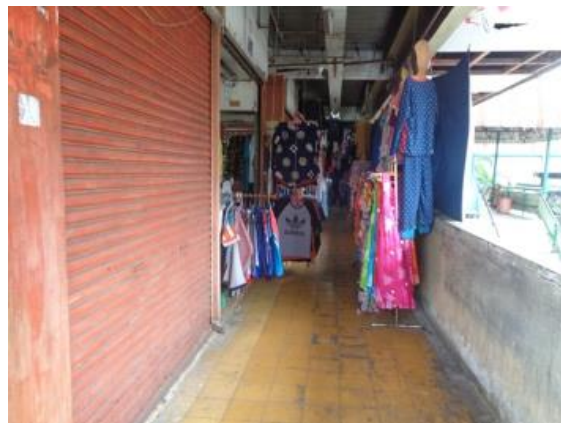
The building has a corridor with 2 m width and 60 m length. Some parts of the corridor are very narrow because sellers make corridor as stall area. There are stairs and escalators to access the building, but at this time, the condition is not feasible because there are no stair railings and the escalators not working properly. The walls of the building have also not maintained and are peeling off.

**Figure 5.** building corridor situation  
(Source: author).

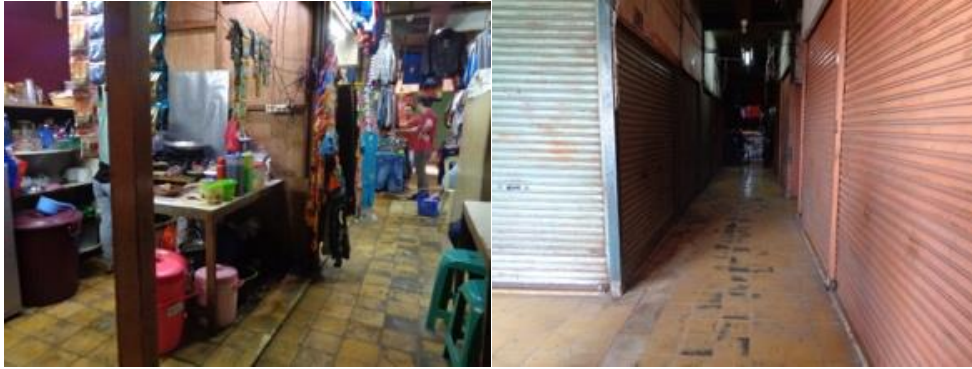
The first-floor condition with maximum floor damage level is 25%. The condition of some terrazzo tiles cracked, the color was faded and eroded. The wall materials used in the building are multiplex and bricks coated with plaster and painted. The damage rate for the wall is 25%. Damage in the form of paint that has peeled and faded stucco has a bumpy or uneven texture, and there are broken walls. The ceiling damage level is 5%. The condition of the sills, doors, and windows is still in good condition and well maintained, because the seller who owns the shop is aware of the safety of their merchandise, so the door is sufficiently maintained. There are no windows in the shop section with a 5% damage rate.

Figure 6. 1st floor condition  
(Source: author)

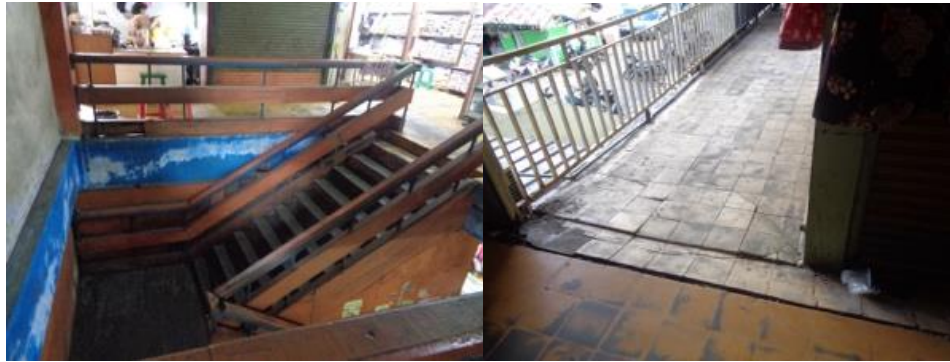
On the second floor, the damage rate is above 25%. The condition of some terrazzo tiles cracked, the color was faded and eroded. On the floor connection, the terrazzo tiles appear to separate from the old building and a new one. That happened because of the decline in the foundation and the absence of dilation at the floor connection of the building. The maximum wall damage rate is 25%. Damage consists of peeling and fading paint, bumpy texture, and there is a broken wall. The condition of the ceiling cover on the second floor is good with a 25% damage rate. The damage happened because of the leak at the connection part of the old and new building. The condition for the door located in non-occupied is not maintaining, there are parts of the door that are damaged and rusty. There is no window in the shop section. The maximum damage for door and windows is 25%. In some shops that not occupy or only to use as warehouses, the condition of the lock damage and many of them are lost.

**Figure 8.** 2nd floor condition  
(Source: author)

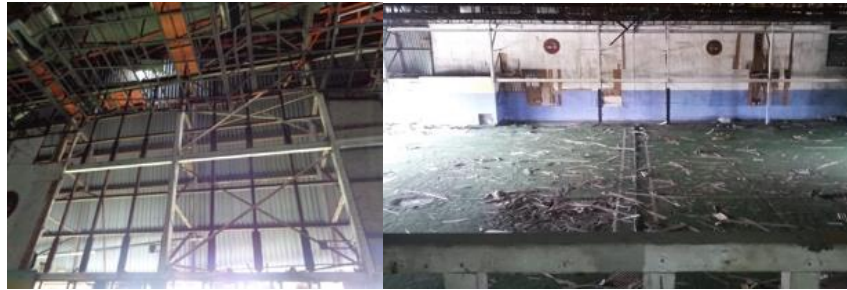
The 3rd-floor using concrete that covered with grass carpet, because it was functioning as a futsal court. Ceramics using in the toilet structure, and bondex in the corridor. The level of floor damage above 25% (i.e. 90%). The damage was almost on the entire floor because it has not used and not occupied for  $\pm$  10 years. The wall construction is multiplex and brick, which is covering by plaster and paint, and ceramics in the toilet area. The damage rate for wall construction is above 25%. The condition of the ceiling cover is very poorly with a level of damage above 25%. Almost all of the ceiling on the third floor has broken, there were only the ceiling frames still installed properly. The condition of the sills, doors, and windows on the third floor almost completely damaged. The damage rate is above 25% (i.e. 90%). The door and window fixtures almost completely damaged and lost too. The door handle and the key are gone. The folding door for the escalator also has damaged and rusted. The condition of the roof cover is still quite good. Damage caused by rusty material and made some parts of the roof leak. Listplank and gutter also not maintained because of the building age, which is already  $\pm$  40 years.

Figure 10. 3rd floor condition  
(Source: author)
