# Performance Evaluation of Pontianak Kapuas Indah Market from Architecture and Behaviour Aspect

M. Ridha Alhamdani<sup>1</sup>, Dian Perwita Sari<sup>2</sup>

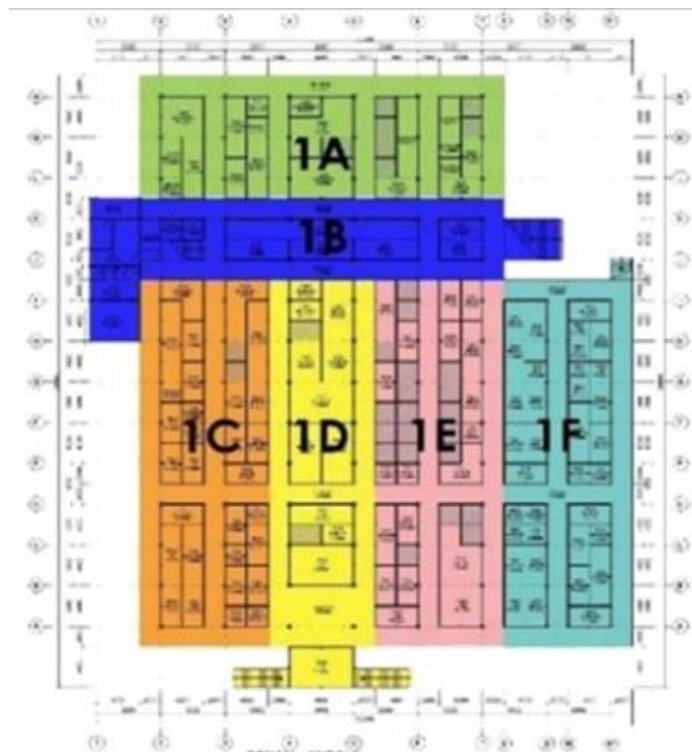
Figure 7. 1st-floor plan  
(Source: author)

The first-floor condition with maximum floor damage level is 25%. The condition of some terrazzo tiles cracked, the color was faded and eroded. The wall materials used in the building are multiplex and bricks coated with plaster and painted. The damage rate for the wall is 25%. Damage in the form of paint that has peeled and faded stucco has a bumpy or uneven texture, and there are broken walls. The ceiling damage level is 5%. The condition of the sills, doors, and windows is still in good condition and well maintained, because the seller who owns the shop is aware of the safety of their merchandise, so the door is sufficiently maintained. There are no windows in the shop section with a 5% damage rate.

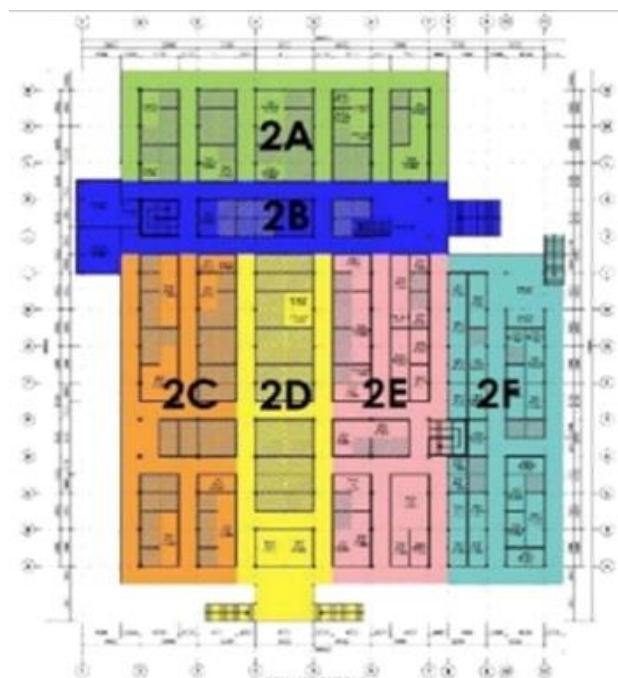
**Figure 9.** 2nd-floor plan  
(Source: author)

On the second floor, the damage rate is above 25%. The condition of some terrazzo tiles cracked, the color was faded and eroded. On the floor connection, the terrazzo tiles appear to separate from the old building and a new one. That happened because of the decline in the foundation and the absence of dilation at the floor connection of the building. The maximum wall damage rate is 25%. Damage consists of peeling and fading paint, bumpy texture, and there is a broken wall. The condition of the ceiling cover on the second floor is good with a 25% damage rate. The damage happened because of the leak at the connection part of the old and new building. The condition for the door located in non-occupied is not maintaining, there are parts of the door that are damaged and rusty. There is no window in the shop section. The maximum damage for door and windows is 25%. In some shops that not occupy or only to use as warehouses, the condition of the lock damage and many of them are lost.

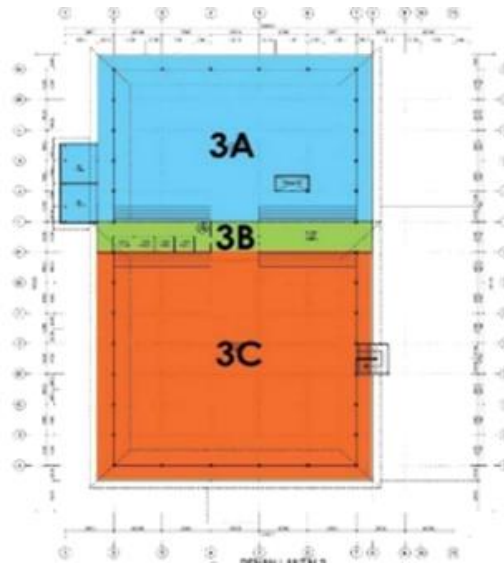
Figure 11. 3rd-floor plan  
(Source: author)

The 3rd-floor using concrete that covered with grass carpet, because it was functioning as a futsal court. Ceramics using in the toilet structure, and bondex in the corridor. The level of floor damage above 25% (i.e. 90%). The damage was almost on the entire floor because it has not used and not occupied for  $\pm$  10 years. The wall construction is multiplex and brick, which is covering by plaster and paint, and ceramics in the toilet area. The damage rate for wall construction is above 25%. The condition of the ceiling cover is very poorly with a level of damage above 25%. Almost all of the ceiling on the third floor has broken, there were only the ceiling frames still installed properly. The condition of the sills, doors, and windows on the third floor almost completely damaged. The damage rate is above 25% (i.e. 90%). The door and window fixtures almost completely damaged and lost too. The door handle and the key are gone. The folding door for the escalator also has damaged and rusted. The condition of the roof cover is still quite good. Damage caused by rusty material and made some parts of the roof leak. Listplank and gutter also not maintained because of the building age, which is already  $\pm$  40 years.

Roof plate condition	Repair/replace damaged roof plate	
FAIR	Accession and relation of space in 3rd floor		Structuring the location / type of merchandise and distribution of magnet activities (gathering spaces, public facilities, restaurants, parks, etc.) so that the distribution of functions and activities can be evenly distributed in the building, in the least distribution of space and can reach all parts
LESS	Accession and relation of space in 1st and 2nd floor		
<b>Time Periode</b>		Short - Intermediate	Short - Intermediate

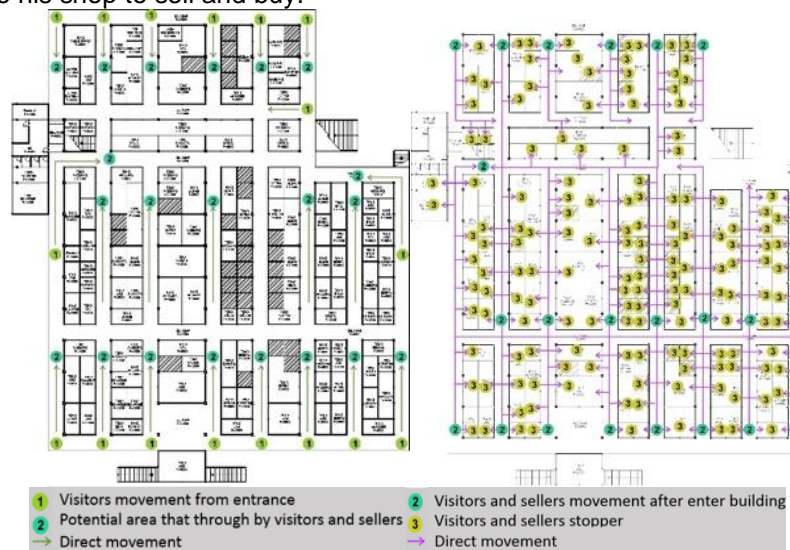
On the first floor, the movement of visitors and shop owners to enter the building can be from anywhere, because the access is open. Visitors move to the shops to buy goods while the shop owner moves to his shop to sell and buy.

Figure 12. behavior mapping analysis for 1st floor  
(Source: author)

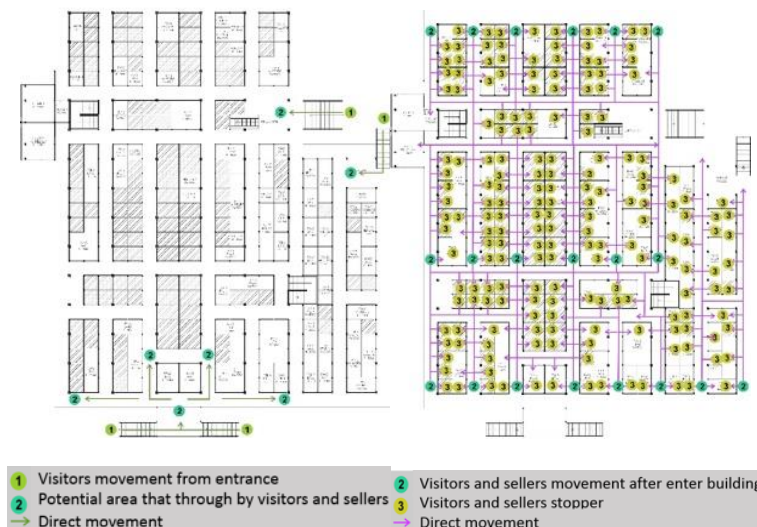
On the second floor, the movement of visitors and shop owners limiting by the entrance access in the form of stairs located on the front side and the right side of the building. The next activity is moves to the shops to buy goods and the seller moves to his shop to sell and buy.

Figure 13. behavior mapping analysis for 2nd floor  
(Source: author)

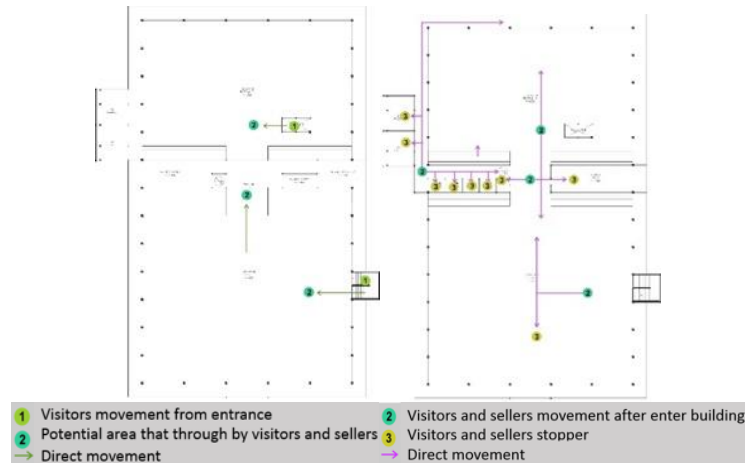
On the third floor, the visitor's movement only through two main access, the stairs on the right side and the former escalator that no longer used anymore. Visitors and market managers could have passed towards the grandstand. Activities on the third floor while still in use are visitors moving directly to the futsal area via stairs. The building manager moves to the cassette storage room through the stands and management stairs. The manager enters the 3rd-floor area bypassing the same access as the visitor to enter the manager's room but has his access to the playroom and cassette storage.

Figure 14. behavior mapping analysis for 3rd floor  
(Source: author)

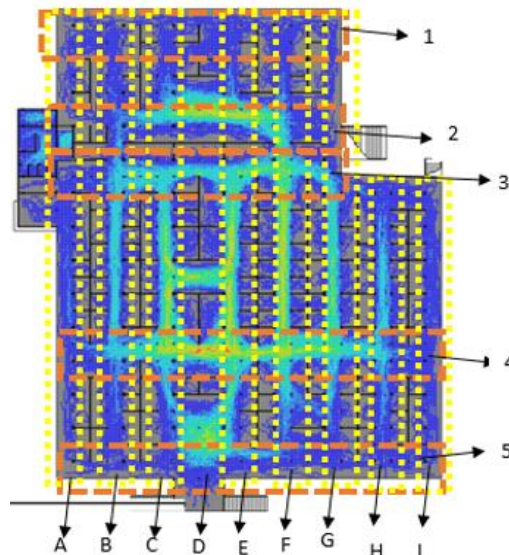
Figure 15. visitor movement analysis at 1st floor  
(Source: author).

From the first-floor plan figure of the Kapuas Indah market above, it can see the area that is often traversed by visitors are corridor 3, 4, 2, C, E, F and G, D, H, and I. This shows that the central corridors, especially corridors 2, 3, 4, C, E, F, G are easily accessible areas, attract and interesting for visitors. Whereas the corridors on the outer and sub-outer (1, 5, A, B, D, H, I) are not interesting

to visit even though this area is close to access.

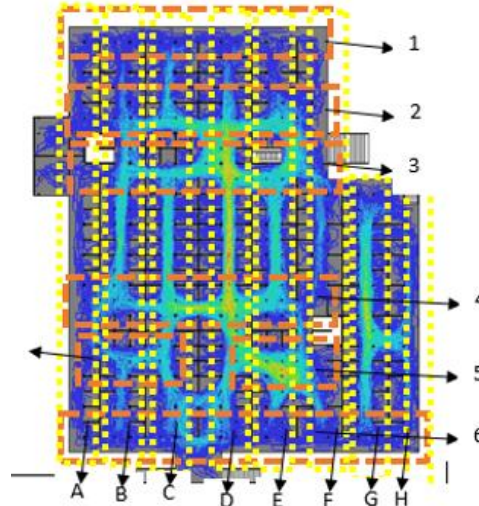
From the analysis of visitor movements on the 2nd floor, it founded that the areas with high movement shown in corridors 2, 3, 4, 5, C, D, E, G. Whereas the areas with low movement are corridors 1, 6, 7, A, B, F, H. Just like the flow of movement on the first floor, the flow of visitors on the second floor tends centered in the middle of the building. The flow of movement at the edge of the corridor tends to be slight. The movement can see in the image below.

Figure 16. visitor movement analysis at 2nd floor  
(Source: author)

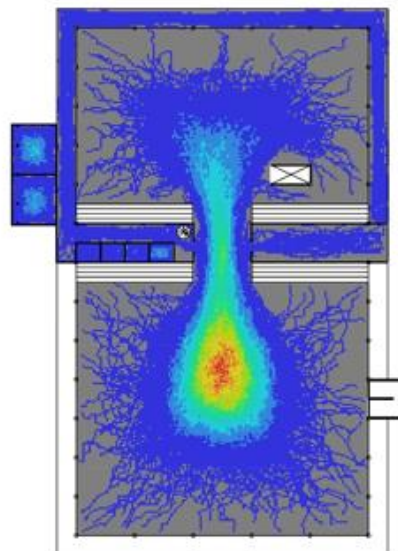
The 3rd-floor area is un-partitioned; the divider is only in the middle for manager access and toilets. From the results of space syntax analysis shows that in the area of the front of the third floor, there is a high concentration of visitor movements, while in the back the low. This caused by the size of the front area that is wider than the back, causing the concentration of movement in the front area.

Figure 17. visitor movement analysis at 3rd floor  
(Source: author)

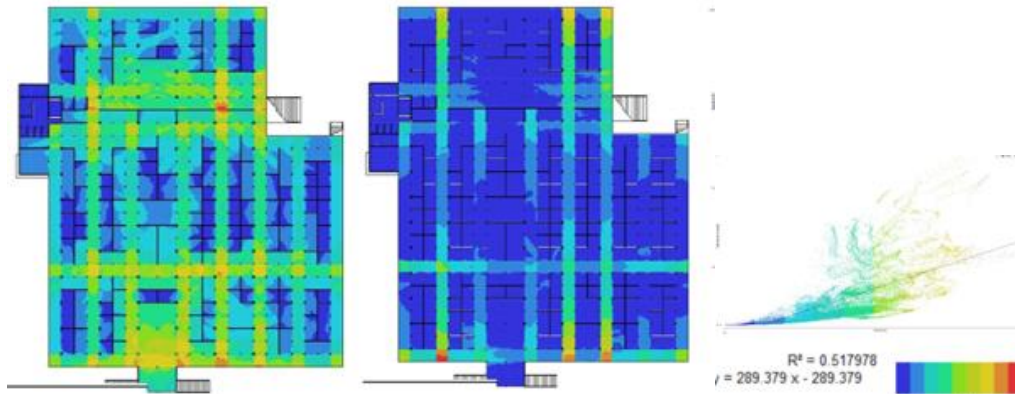
integrity in the corridor access lane in the front of the building to the next store, the area has the potential for more space user activity. The results of connectivity and integrity values produce an intelligibility value of  $R = 0.46669-0.517978$ . Where R is the value of intelligibility. When viewed from the parameters of achieving effective space values, the first floor is categorized LESS in the ease of achieving and linking space. The relationship between the three components shown in the figure below.

**Figure 18.** (From left to right) Connectivity, Integrity, Intelligibility at 1st floor  
(Source: author)

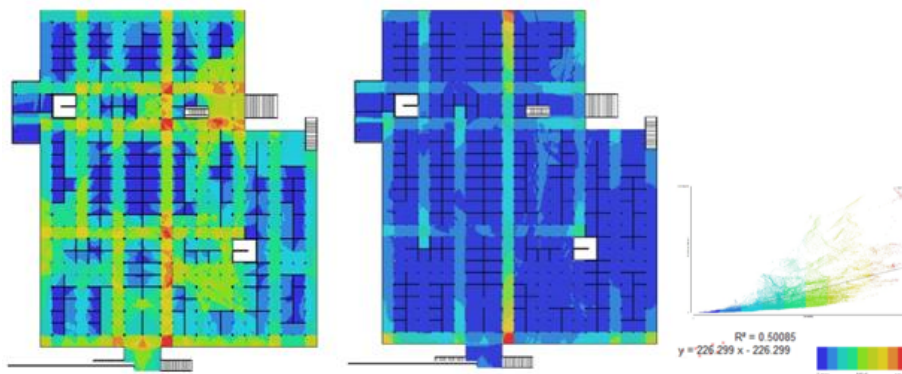
In the analysis of connectivity on the second floor, the relationship between shop spaces connected with the corridors around it, a reddish-yellow gradation seen between the access road in the form of corridors that make connecting spaces in the second floor. The integrity of the second floor found the highest integrity in the central corridor access of the building has the potential for more movement and activities in it. The results of the correlation value of connectivity and integrity produce an intelligibility value of  $R = 0.470214 - 0.50085$ . When viewed from the parameters of the achievement of effective spatial value, second-floor space is categorized LESS in the ease of achieving and linking space. This can see in the image below.

**Figure 19.** (From left to right) Connectivity, Integrity, Intelligibility at 2nd floor  
(Source: author)

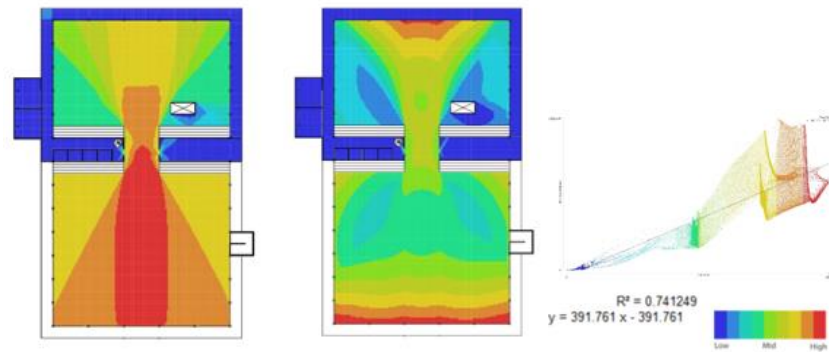
Connectivity analysis of the 3rd-floor of the Kapuas Indah Market which only has 1 corridor in the room to connect 2 areas of the futsal field, the results are a very high connectedness analysis, this caused by the absence of a room divider in this area. The highest connectivity value was in the front area. The integrity analysis Kapuas Indah Market found the highest integrity in the front area of the floor, the reddish color gradation very clearly seen in this area because there is no boundary space, while the space behind it has an integrity value less than front area. The results of the correlation between connectivity and integrity values produce an intelligibility value of  $R = 0.761905-0.741249$ . When viewed from the parameters of achieving effective space values, the third floor of Kapuas Indah Market categorizing FAIR in the ease of achieving and linking space.

**Figure 20.** (From left to right) Connectivity, Integrity, Intelligibility at 3rd floor  
(Source: author)
